Spring protection and watercourse and its relationship with environmental quality in family property, in the Caparaó region of Espírito Santo, Brazil

Proteção de nascente e o curso d'água e sua relação com a qualidade ambiental em propriedade familiar, na região do Caparaó capixaba

ARTIGO

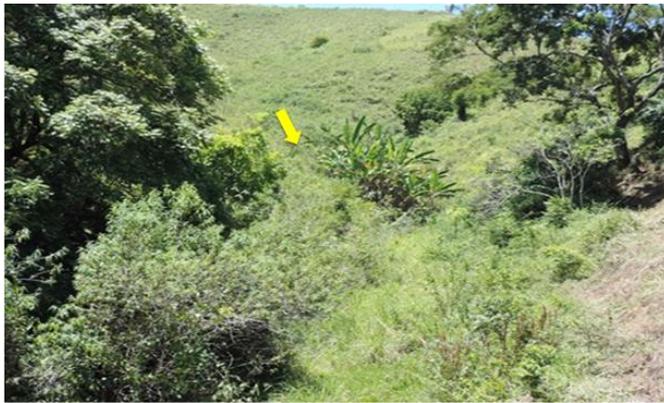
Figure 2. Location of the main spring from Córrego Novo, on a family farm of Córrego São Sebastião watershed, rural community Rainha da Paz, in Alegre municipality, Espírito Santo.

The rural property has a main spring, which before “Water Planters” project was unprotected, being accessed by cattle around spring and also along the entire length of watercourse. Figure 2 shows that the spring is located close to the property's limits and its recharge area is outside property. It is worth noting the existence of a remnant native vegetation close to the rural property. This forest fragment has secondary vegetation in a medium stage of natural regeneration.

exposure. However, in the spring surroundings there are steep slopes (Figure 2), that suffer more impacts during rainy periods, being more susceptible to erosion and silting, which together with cattle trampling cause soil compaction, making difficult infiltration and percolation of water in soil.

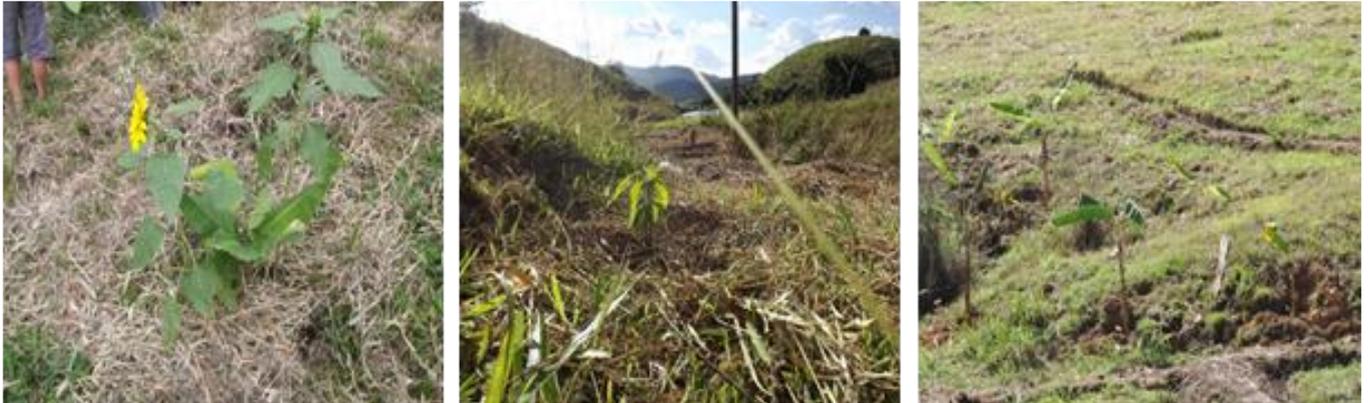
Figure 5. Species cultivated in the APPs under study in Córrego Novo, on a family farm of Córrego São Esperidião watershed, rural community Rainha da Paz, in Alegre municipality, Espírito Santo.

In view of all these factors, in absence of grazing and animals trampling (cattle) within APP area, progress is being observed of improving the environmental quality of this spring, since it has a topography with low slope, decreases even more degradation and, consequently, the silting process, improving

water quality and complying the environmental legislation (Figure 5).
